Report Number: 2295-21879

Product Description: Water conditioning device model 4" WSPS (HDC)

Scope of Evaluation: The purpose of the testing was to determine what effect the samples described

Conclusion: The pool with the water conditioning device installed had an average of 23%

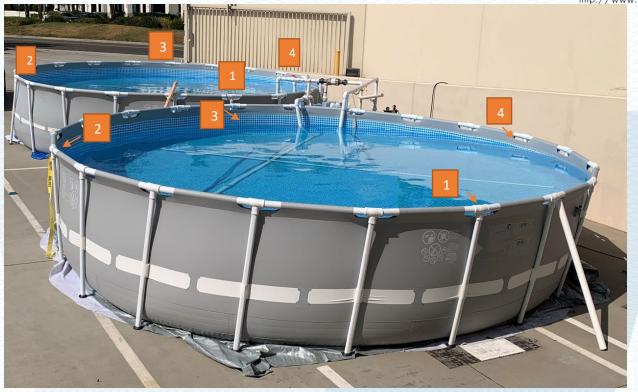
Figure 1 – Two Pools Layout

The water drop measurements were recorded at four points around the perimeter of each pool at 90° increments (Figure 1). These values are recorded in table 1. The difference between successive dates of measurement at each location is recorded in table 2. Also in table 2 the overall difference in the drop from the the first date to the last date is recorded as 5-24 total. Then the difference in the drop at each point between Pool 1 and Pool 2 was calculated (P2-P1), this difference shows that there was a shift at point 4 in Pool 1 of 0.125 inches. So that difference was backed out of the point 1 drop (5-24 Total adjusted for pool shift) for a net drop of 1.5 inches at point 1. The volumetric change is P1 and P2 was calculated in table 3.

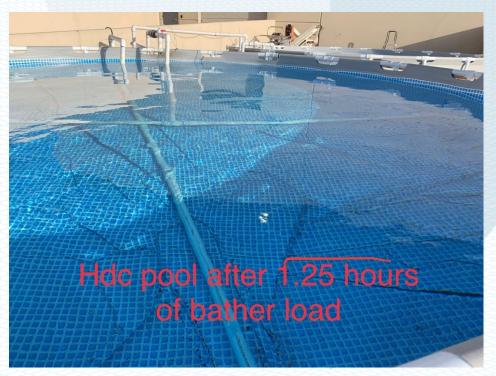
Figure 6- HDC Treated Pool After 1.25 Hours of Introducing the Bather load

Observations: The combined chlorines for the HDC pool were consistently lower than the control pool especially after adding the chlorine. Figures 6 and 7 show the difference in the dissipation of the bather load observed after several days of running the pools. When the addition of bather stopped the variation between the 2 pools dropped off. The HDC treated pool used 0.3% less chlorine than the control pool.

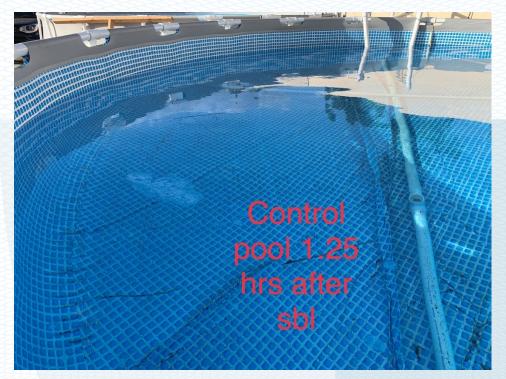
Figure 7 – Control Pool After 1.25 hrs of Introducing the Bather Load – Material Still Floating

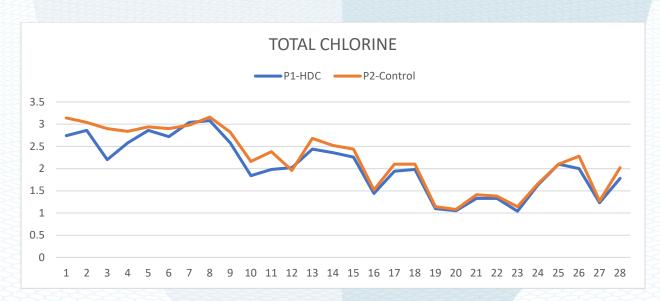
Graph 2- Total Chlorine in Both Pools

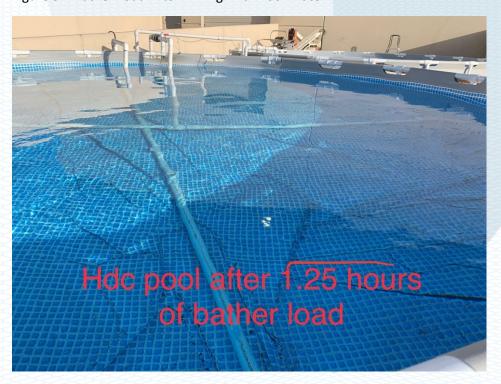
Figure 6- HDC Treated Pool After 1.25 Hours of Introducing the Bather load

Observations: The combined chlorines for the HDC pool were consistently lower than the control pool especially after adding the chlorine. Figures 6 and 7 show the difference in the dissipation of the bather load observed after several days of running the pools. When the addition of bather stopped the variation between the 2 pools dropped off. The HDC treated pool used 0.3% less chlorine than the control pool.

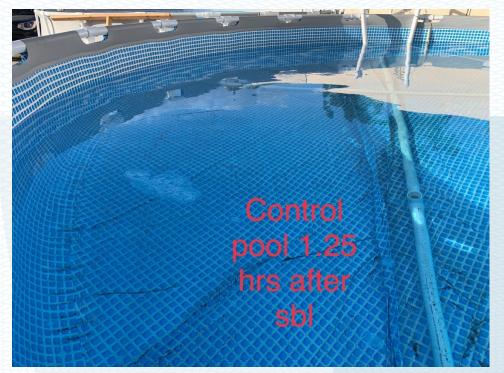
Figure 7 – Control Pool After 1.25 hrs of Introducing the Bather Load – Material Still Floating
